Bradley-Hole Schoenbach Landscape Architects		Project	549 HISTORIC CORE
		Client	RHS
		Dwg title	LANDSCAPE MASTERPLAN - DETAILED PLAN 02
		Dwg ref	549.F.101
		Scale	1:150 @ A1
		Status	CONSTRUCTION
		Drawn	EB
		Checked	VG

Guildford Design Awards 2023 Entry Requirements

RHS Garden Wisley – The Old Laboratory

Conservation Project

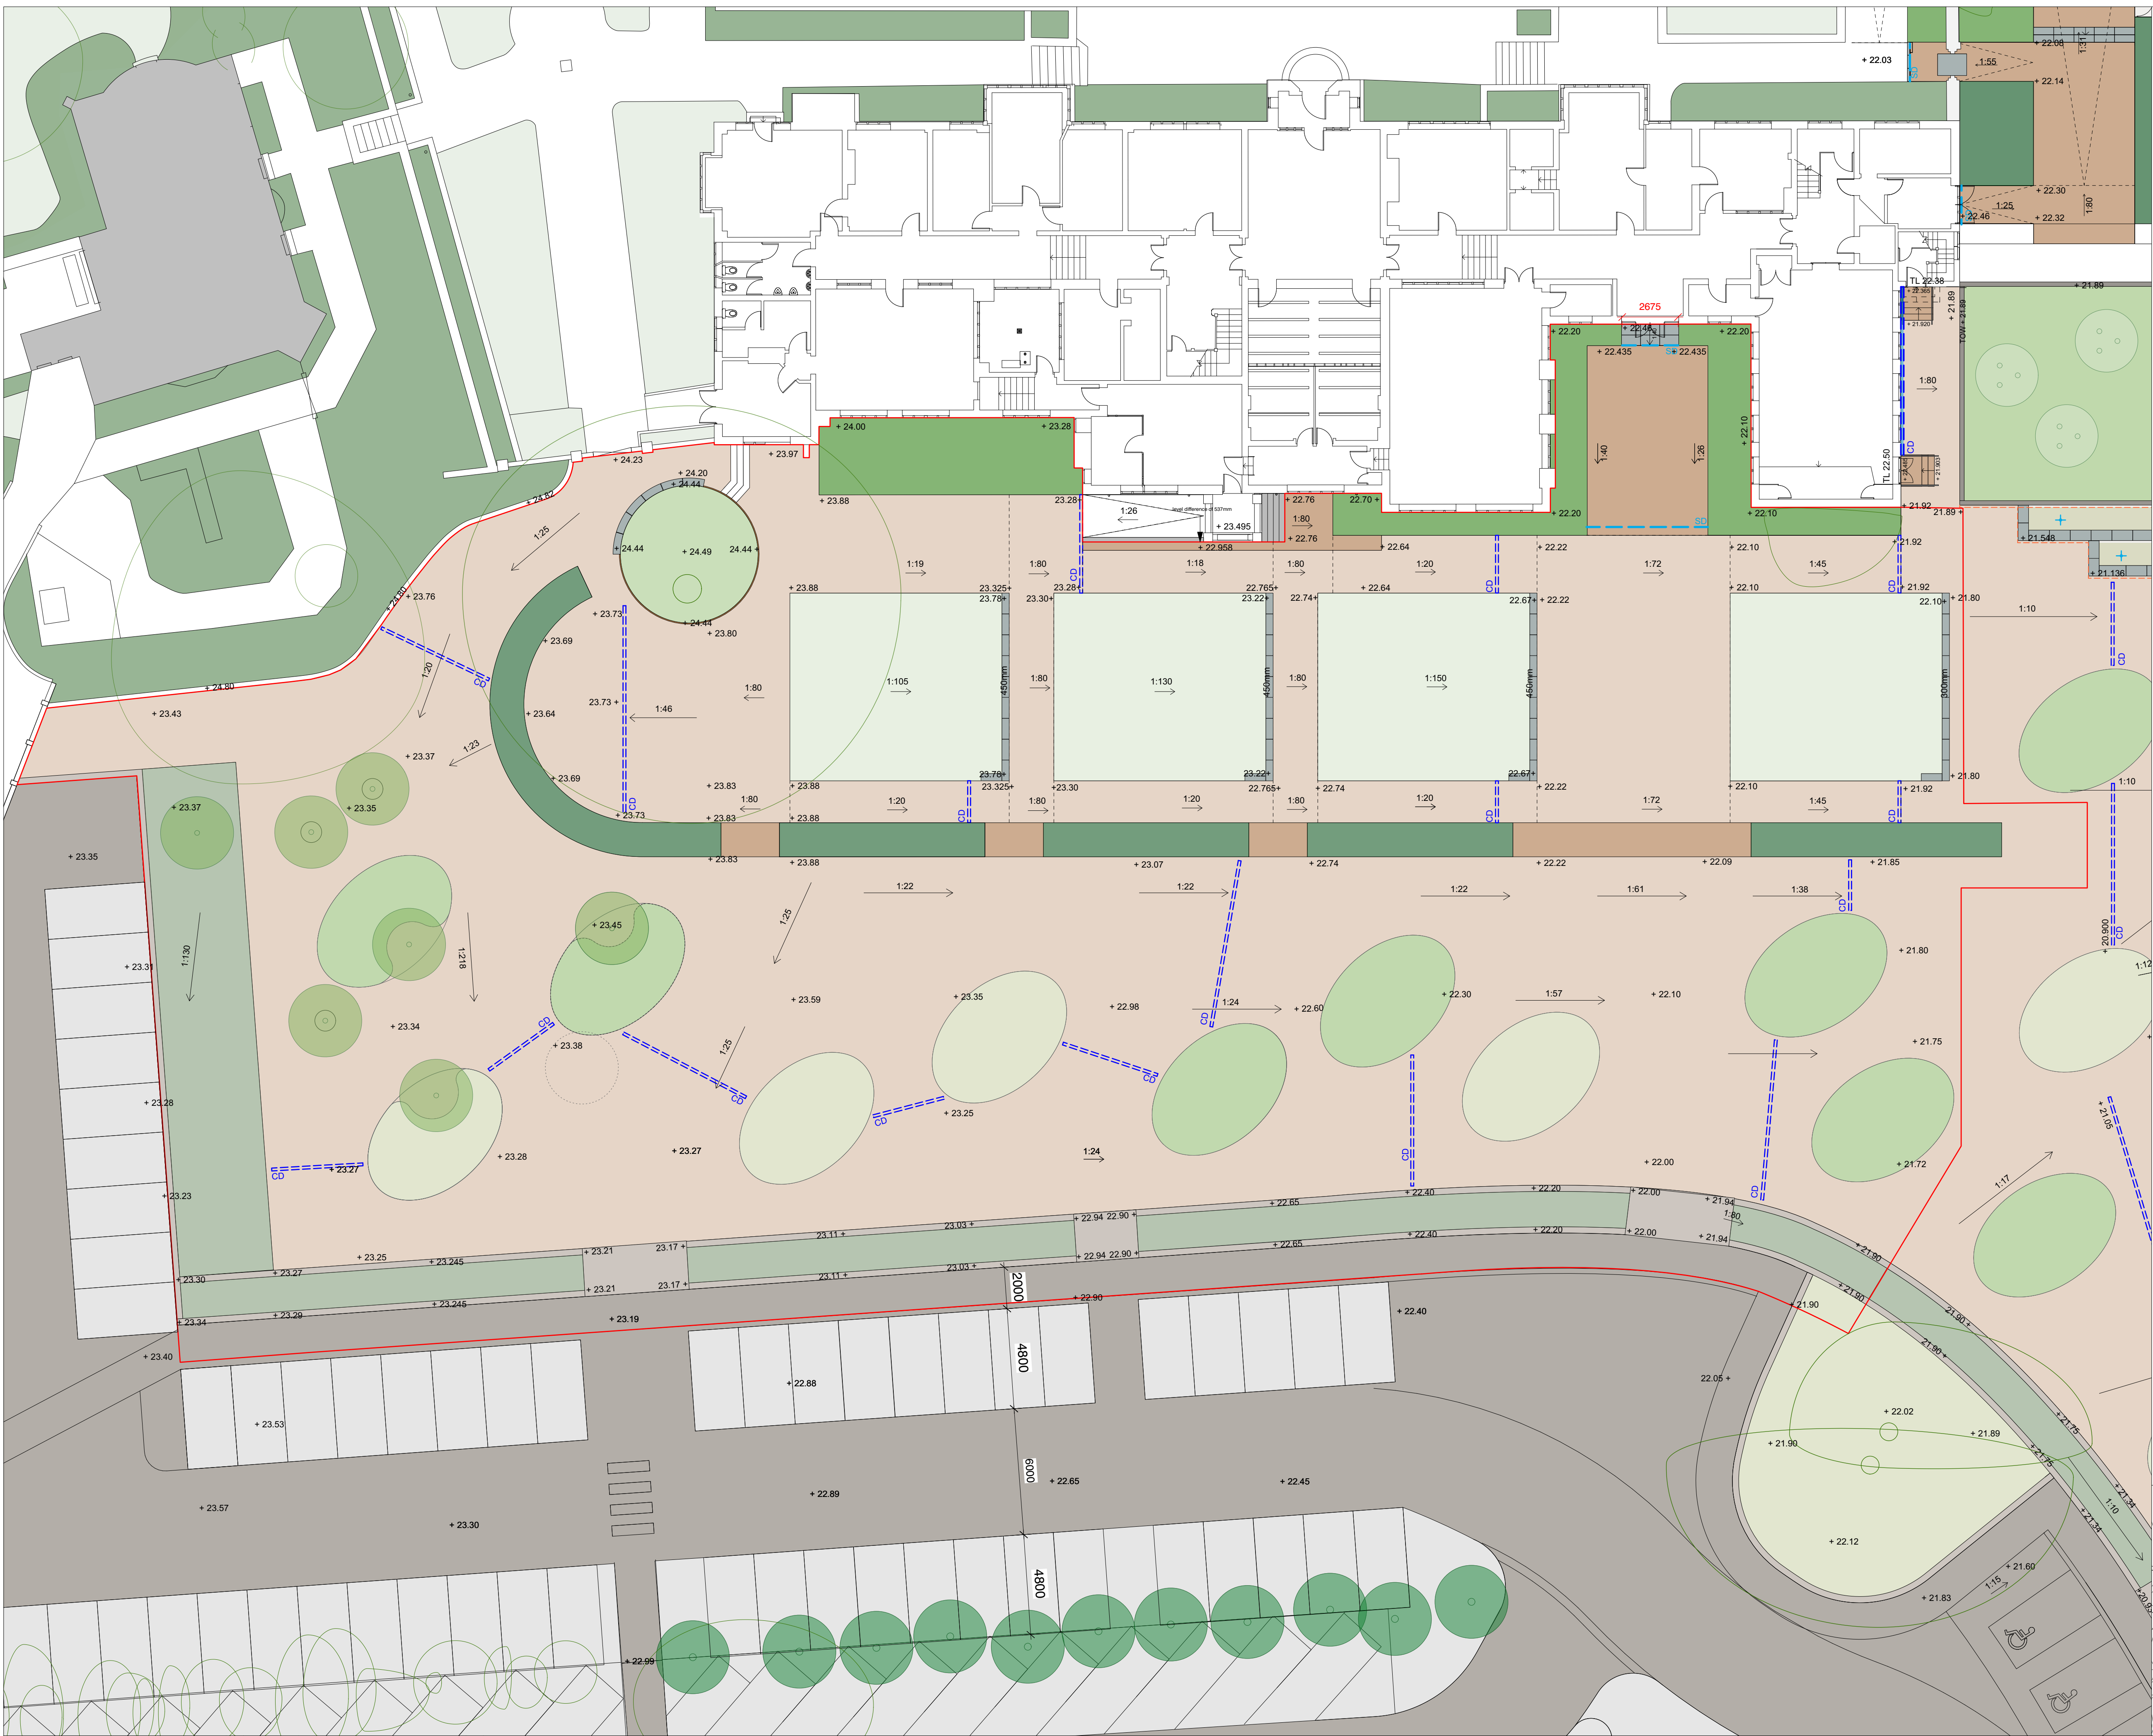
- KEY**
- RIBBON PLANTING:
RHS supply and planting
 - LABORATORY BUILDING:
Retain existing, partly new planting along the building, RHS supply and planting

- EXISTING PLANTING
 - CLIPPED HEDGES:
Taxus baccata, RHS supply, Landscape contractor planting
 - MOUNDS, Undulated clipped hedges:
Fagus sylvatica, RHS supply and planting, refer to BHSLA 549.F.28

- MOUNDS Undulated clipped hedges:
Taxus baccata, RHS supply and planting, refer to BHSLA 549.F.28
 - TERRACED LAWNS
 - TREE TYPE D(semi mature):
Cercis siliquastrum, supplied by RHS

- EXISTING TREES
 - Tar and chip (to match existing)
 - BRICK PAVING :
Chelmer Valley, Westminster
 - STONE:
Dietfurt Dolomite
 - RETAINING WALLS/STEPS:
 - BRIDGES:
in situ concrete with Dietfurt Dolomite stone band

- EXISTING BUILDINGS
 - TARMAC ROAD
 - GRAVEL ROAD
 - BESPOKE BENCH, tbc
 - EXISTING WALLS/STEPS
 - LANDSCAPE PHASE 2
 - + 0.00 PROPOSED LEVELS
 - CHANNEL DRAIN

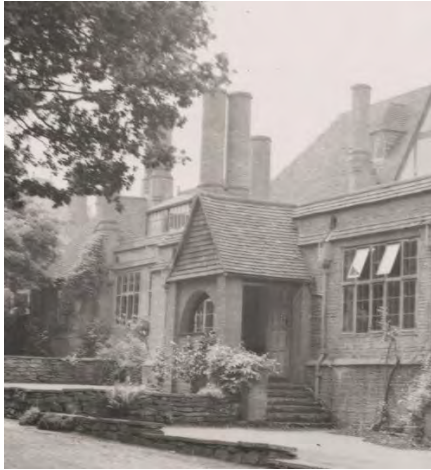
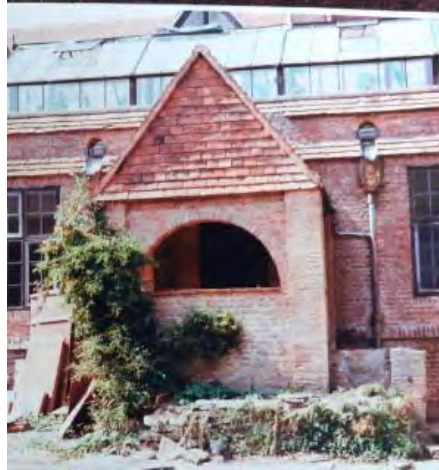
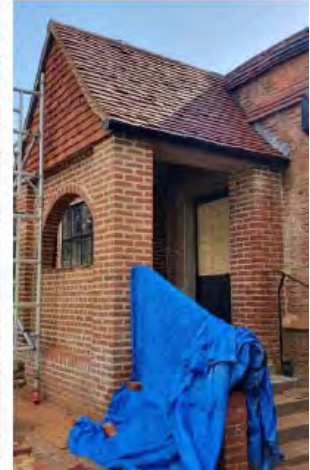
Porch Reconstruction 2021/22

c. 1920

1980s

2022
